# **CHAMBERLAIN HOUSE**

# HISTORIC STRUCTURE REPORT

Women's Rights National Historical Park Seneca Falls, New York

August 2001

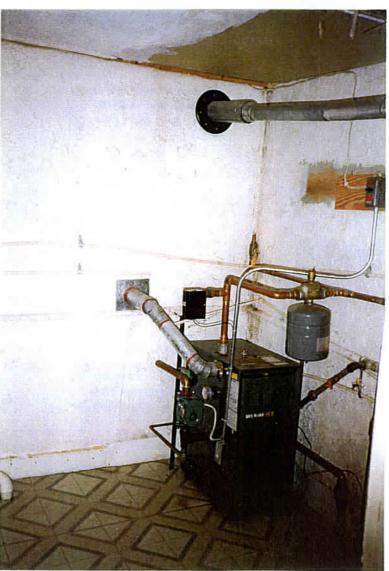
Figure 39.

The house is heated by a gas-fired, hot-water baseboard heating system that probably dates to the Baldwin's acquisition of the house in 1963. The boiler for this system is a low pressure type manufactured by Weil-McLain in 1991, located in Room 107 (fig. 39). The heat is regulated by a thermostat mounted to the east wall of Room 103. The gas meter for the house is located at the exterior east wall.

Chamberlain House utility room (Room 107), view looking southeast, May 2001 (left).

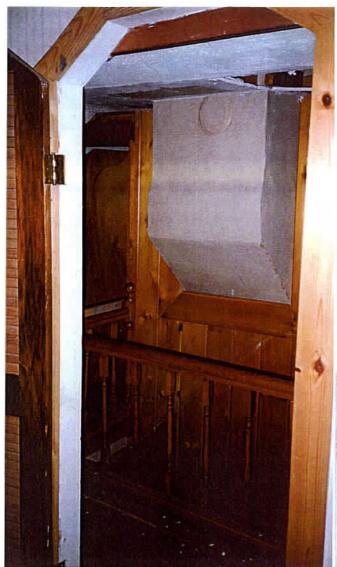
Figure 46.

Three former chimneys are missing today above the roof line. The most recent two chimneys are a "hung" type supported by the framing of the second-story partition walls. These survive today below the roof at the west wall of Room 201, and at the west wall of Room 203 (figs. 46 and 51). Each chimney is equipped with a thimble for a single stove pipe, and is finished with a later gypsum plaster. These chimneys may date to 1938 when other alterations were made to the house. It is not known when they were removed from above the roofline.

The two later chimneys are located at the west walls of Rooms 201 and 203 (figs. 46 and 51). These are hung chimneys that project from the wall and were designed to vent a single stove pipe. A date of circa 1938 has been assigned to these chimneys, based on the modern gypsum plaster that was used to finish them. The old chimney appears to have been demolished prior to the installation of these later chimneys, since the old chimney would have risen in the space now occupied by the hung chimney in Room 201.

Chamberlain House, upper stair hall (Room 201), view looking southwest, May 2001 (left). Note hung chimney at west wall.

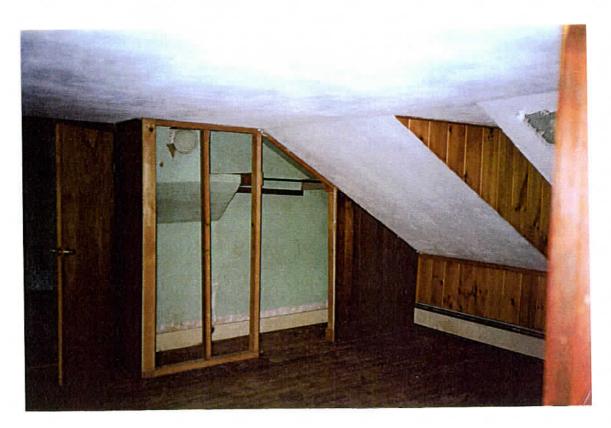
Figure 51. Chamberlain House middle bedroom (Room 203), view looking northwest, May 2001.
